UNITED STATES ENVIRONMENTAL PROTECTION AGENCY
REGION 5
77 WEST JACKSON BOULEVARD
CHICAGO, IL 60604-3590

Re: Notice of Violation
Compliance Evaluation Inspection
ILD 005 215 769

On August 28, 2014 a representative of the U.S. Environmental Protection Agency inspected the BASF Corporation facility (BASF) located in Kankakee, Illinois. As a large quantity generator of hazardous waste, BASF is subject to the Resource Conservation and Recovery Act, 42 U.S.C. § 6901 *et seq.* (RCRA). The purpose of the inspection was to evaluate BASF's compliance with certain provisions of RCRA and its implementing regulations related to the generation, treatment and storage of hazardous waste. A copy of the inspection report is enclosed for your reference.

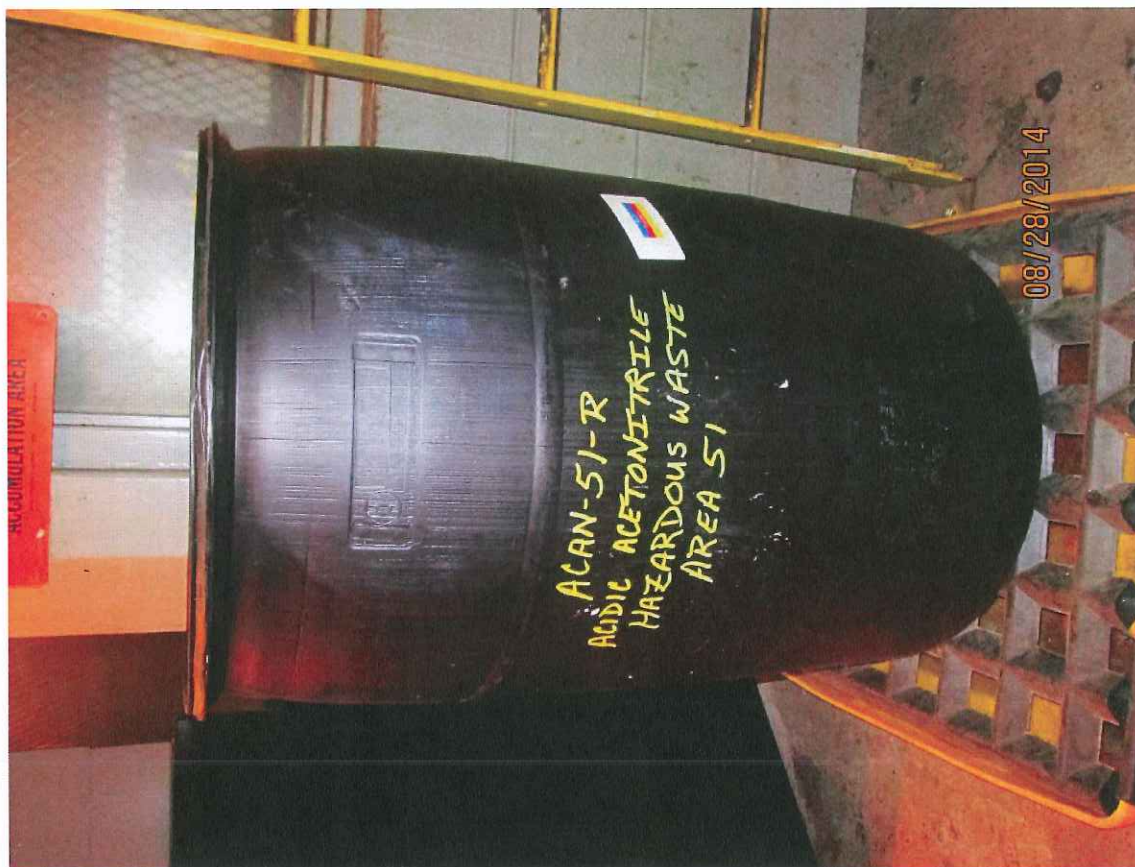
Photo 1. Photographer: G. Scambiatterra. Time: 1:15 p.m.
Description: SAA on the 2nd floor of Area 51, container of acidic acetonitrile waste

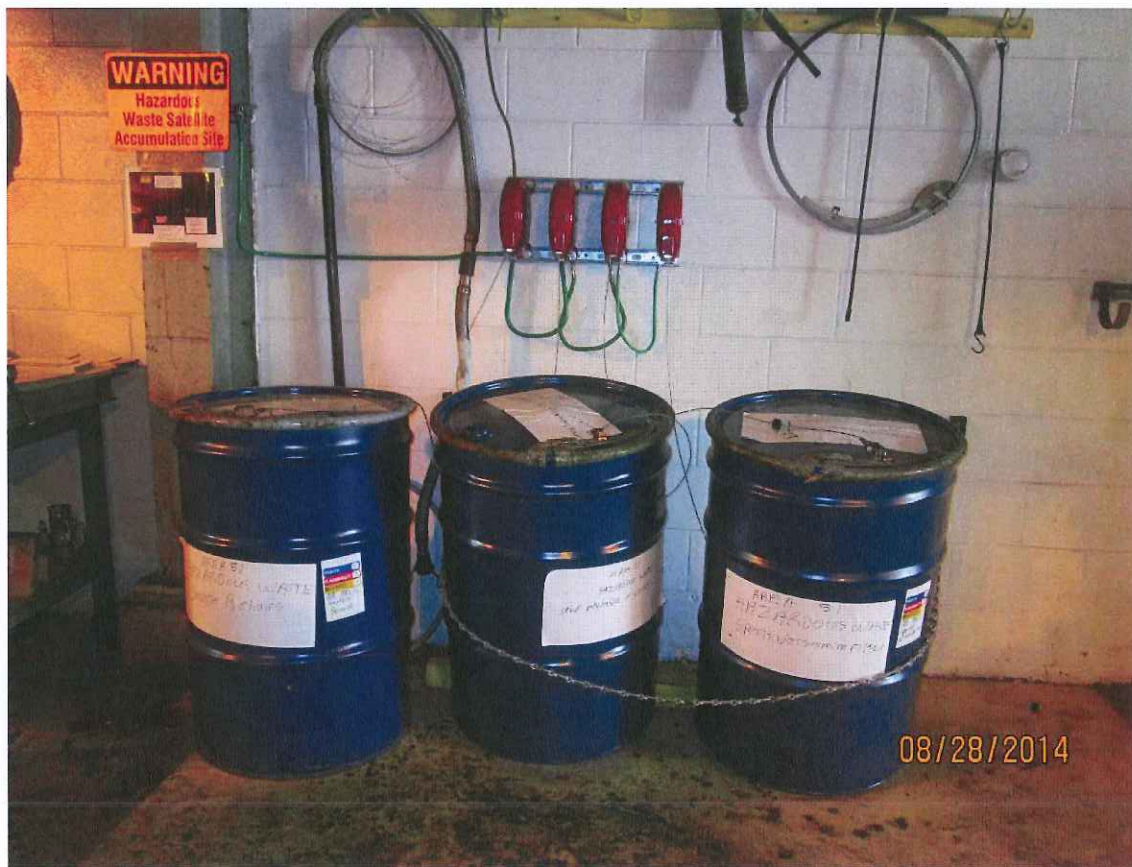
Photo 2. Photographer: G. Scambiaterra. Time: 1:20 p.m.
Description: SAA was on the 1st floor in Area 51, three containers of hazardous waste.
Left container: sample retains. Middle container: spent polyamide filters.
Right container: spent versamine filters.

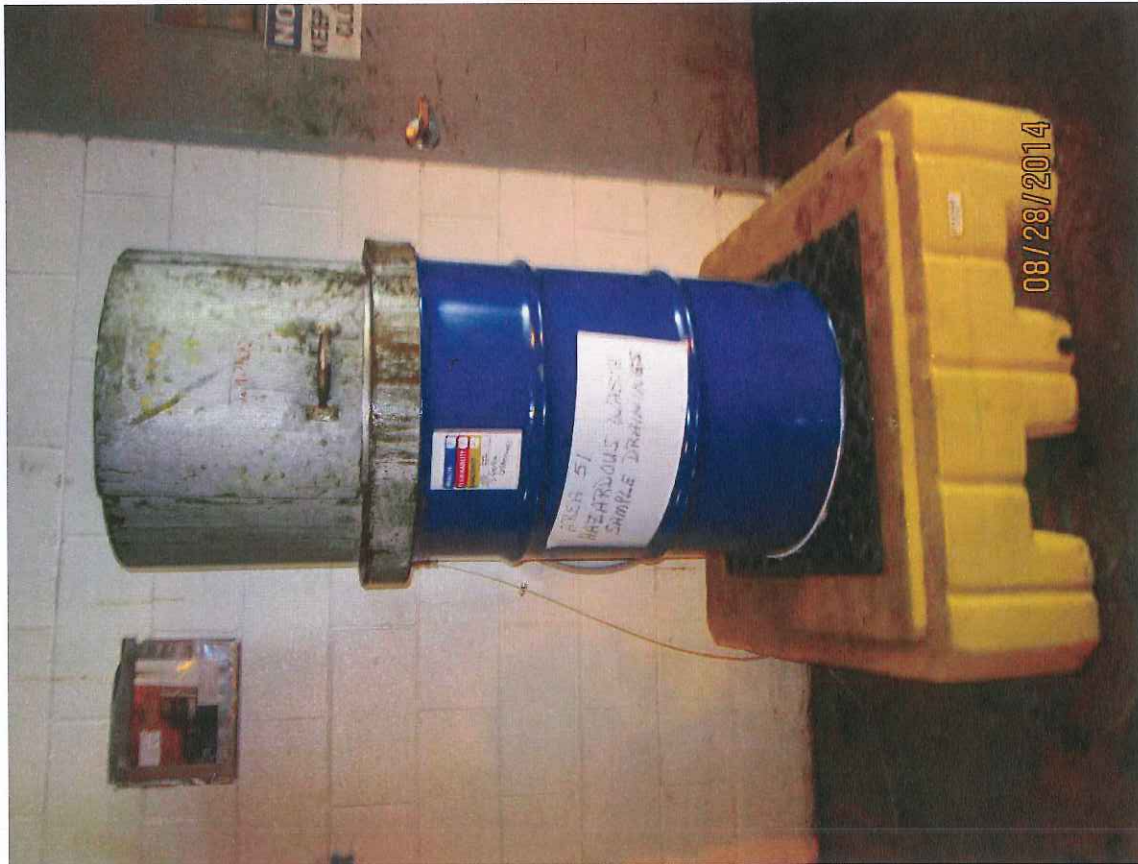
The BASF site inspection began at approximately 1:10 p.m. in Area 51, which is comprised of two floors. Here, amine-based resins are mixed with bisphenol A (BPA) to make formulation material for different types of adhesives. This area had three satellite accumulation areas (SAAs). The first SAA we walked to was on the 2nd floor and held a container of acidic acetonitrile waste (*see* photo 1). The next SAA was on the 1st floor and I observed three containers of hazardous waste retains and filters (*see* photo 2). The third SAA was also on the 1st floor and one container of hazardous waste sample draining was in this area (*see* photo 3).

Photo 3. Photographer: G. Scambiaterra. Time: 1:20 p.m.
Description: SAA was also on the 1st floor and of Area 51, hazardous waste sample draining (liquid).

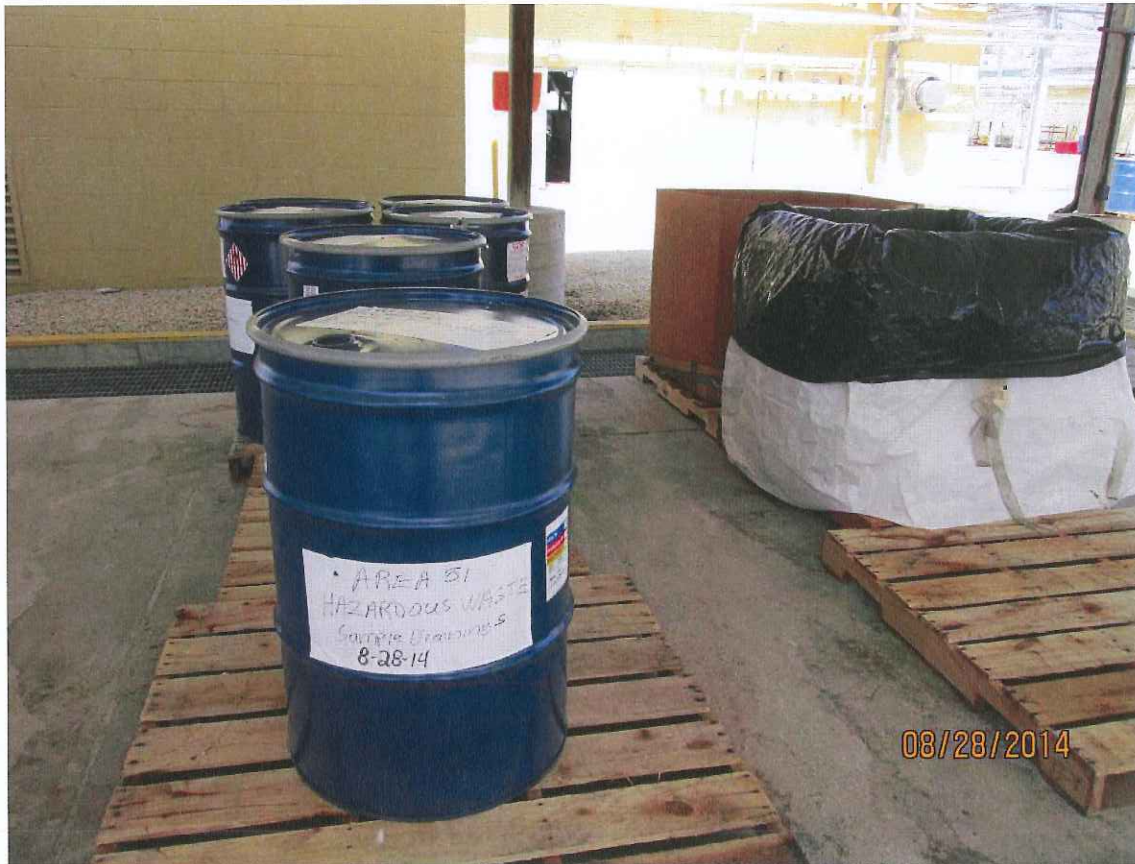
The next area we walked to was the less than 90-day hazardous waste storage area. There were several containers of hazardous waste in this area. There were six 55-gallon containers of hazardous waste in one row and to the right, an open, box that was lined with black plastic, holding un-punctured cans of spray paint waste (*see* photo 4). The lined box of paint can waste was not marked with the words "Hazardous Waste" and it was not dated. When I asked Mr. Hull about the box and its contents, he told me he wasn't sure why it was not properly marked. He also told me he thought the waste had been accumulating here for about three or four months. I reminded Mr. Hull about the 90-day accumulation requirement for onsite hazardous waste. He responded that it would be handled as soon as possible. Also in this area I noted a 55-gallon container with smaller waste paint containers within (*see* photos 5-6). The 55-gallon container was labeled with the words "Hazardous Waste," however, it was not dated with the accumulation start date. I pointed this out to Mr. Hull.

Photo 4. Photographer: G. Scambiaterra. Time: 1:27 p.m.
Description: six 55-gallon containers of hazardous waste in one row and to the right, box lined with black plastic, holding un-punctured cans of spray paint waste

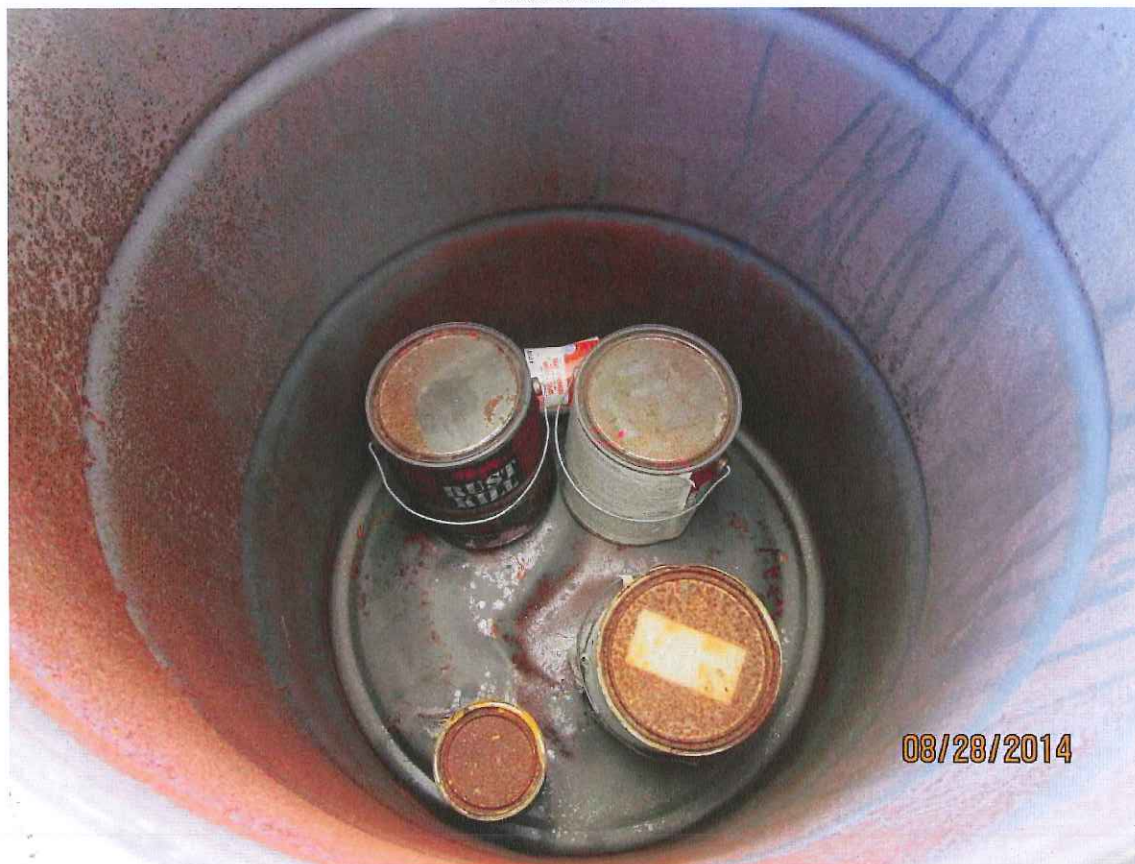
Photo 5. Photographer: G. Scambiaterra. Time: 1:32 p.m.
Description: 90-day Hazardous Waste Storage Area: 55-gallon container with smaller
waste paint containers within

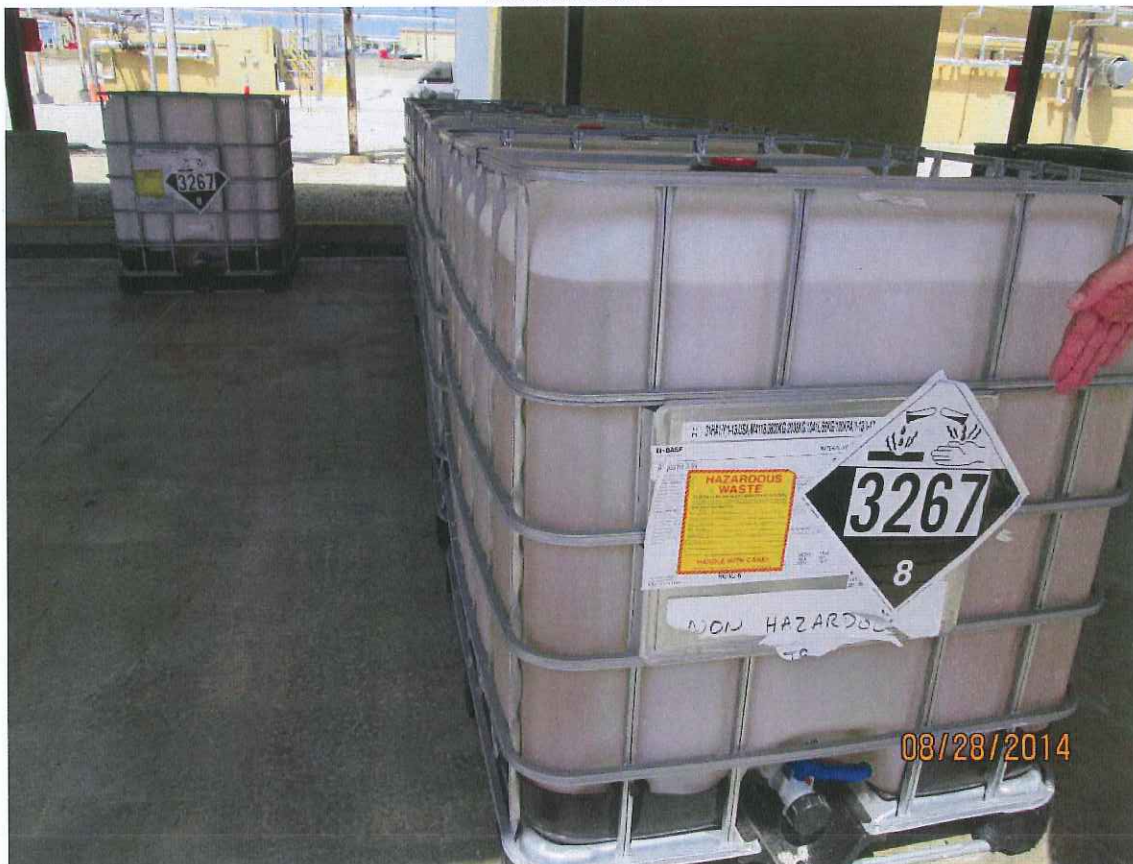
We continued to walk around the hazardous waste storage area and came upon several more containers. Six 250-gallon containers (totes) were holding hazardous waste generated from off-spec Aliquot 336 material (*see* photo 7). Mr. Hull informed me that they were never able to find a buyer for the material and thus were left to dispose of it as hazardous waste. Nearby, there were thirteen 55-gallon containers of solvent destined for

Photo 7. Photographer: G. Scambiaterra. Time: 1:43 p.m.
Description: Six 250-gallon containers (totes) holding hazardous waste generated from off-spec Aliquot 336 material.

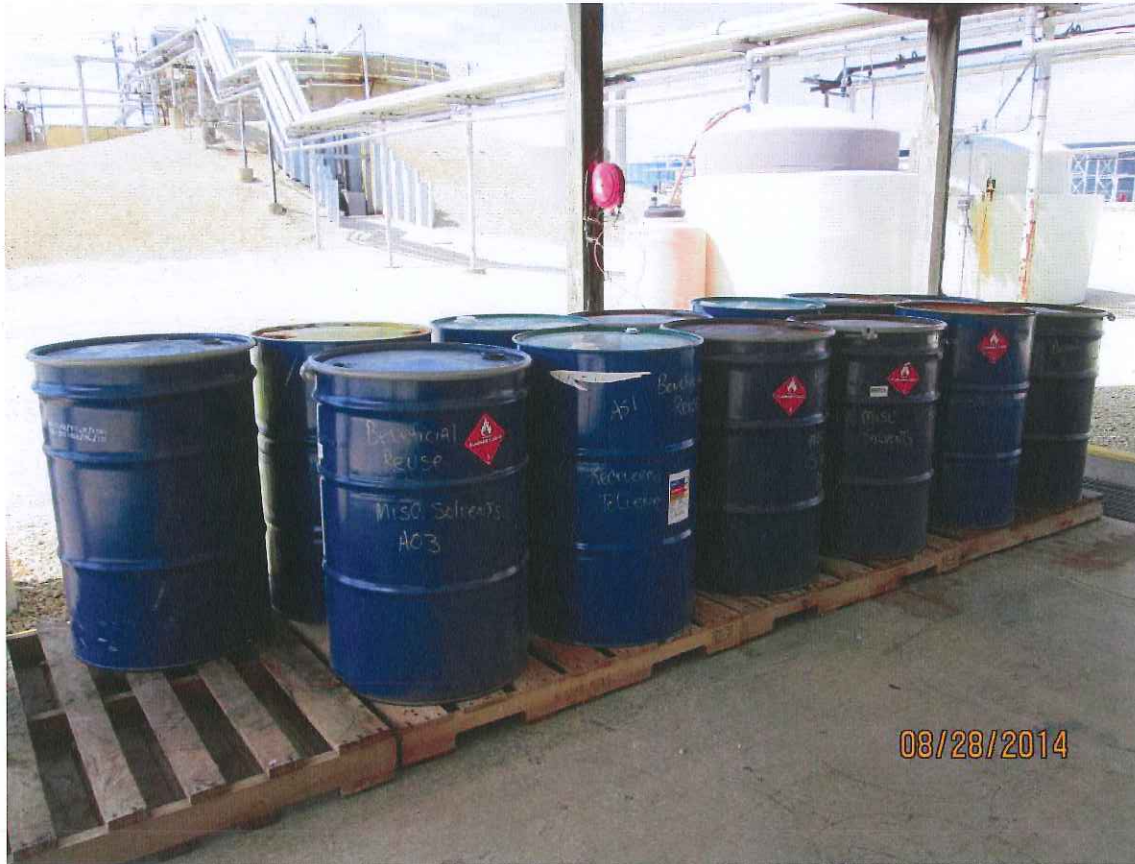
Photo 8. Photographer: G. Scambiaterra. Time: 1:46 p.m.
Description: Thirteen 55-gallon containers of solvent destined for beneficial reuse at either Buzzi Unicem in Greencastle, Indiana or Green America Recycling, LLC in Hannibal, Missouri.

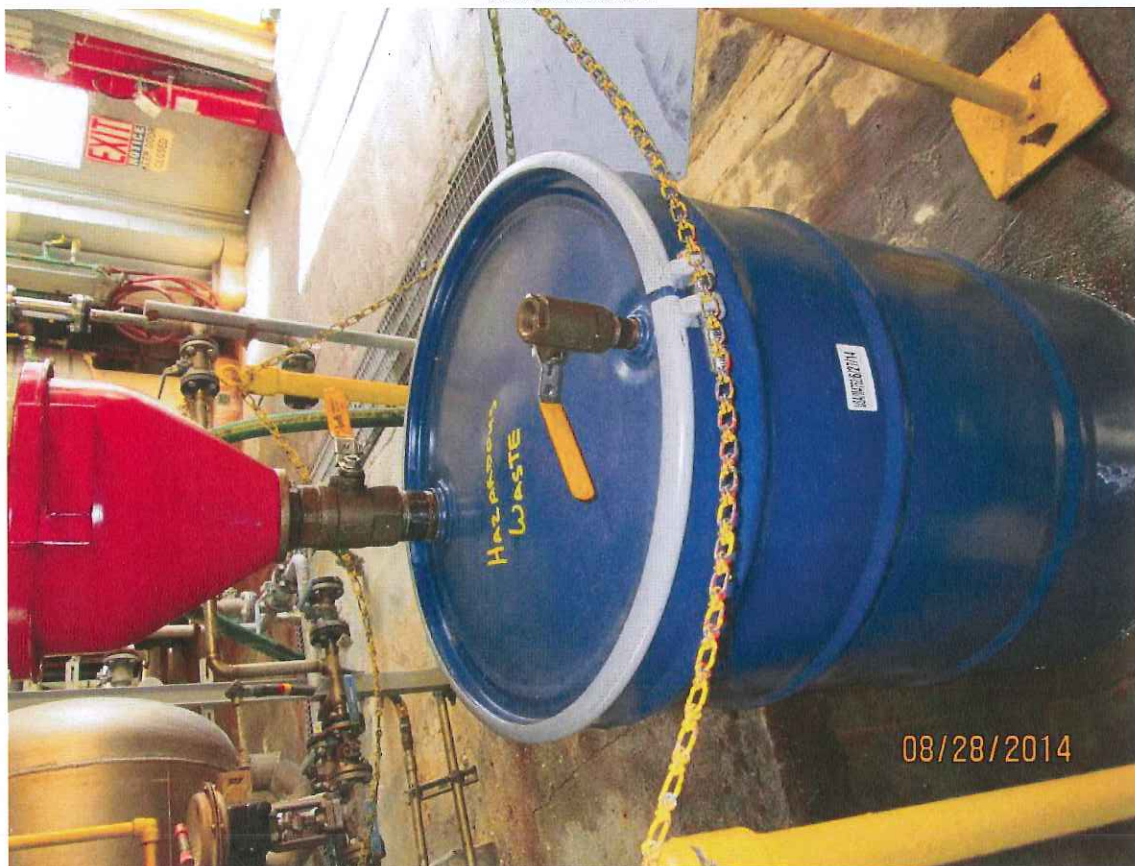
The next area we inspected was Area 21. Here, vitamin E is made by splitting vegetable oil distillate (VOD). A barisol oil waste is generated from this process and it's been identified as a hazardous waste because it comes in contact with ethylene dichloride in the manufacturing process. We walked over to the SAA and I observed a 55-gallon container of this barisol oil/VOD hazardous waste (*see* photo 9).

Photo 9. Photographer: G. Scambiaterra. Time: 1:52 p.m.
Description: SAA at Area 21, 55-gallon container of barisol oil/VOD hazardous waste.
